Performance of Earthquake Damage Beams Repaired via Epoxy Injection

Mehdi Sarrafzadeh, Ken Elwood - University of Auckland

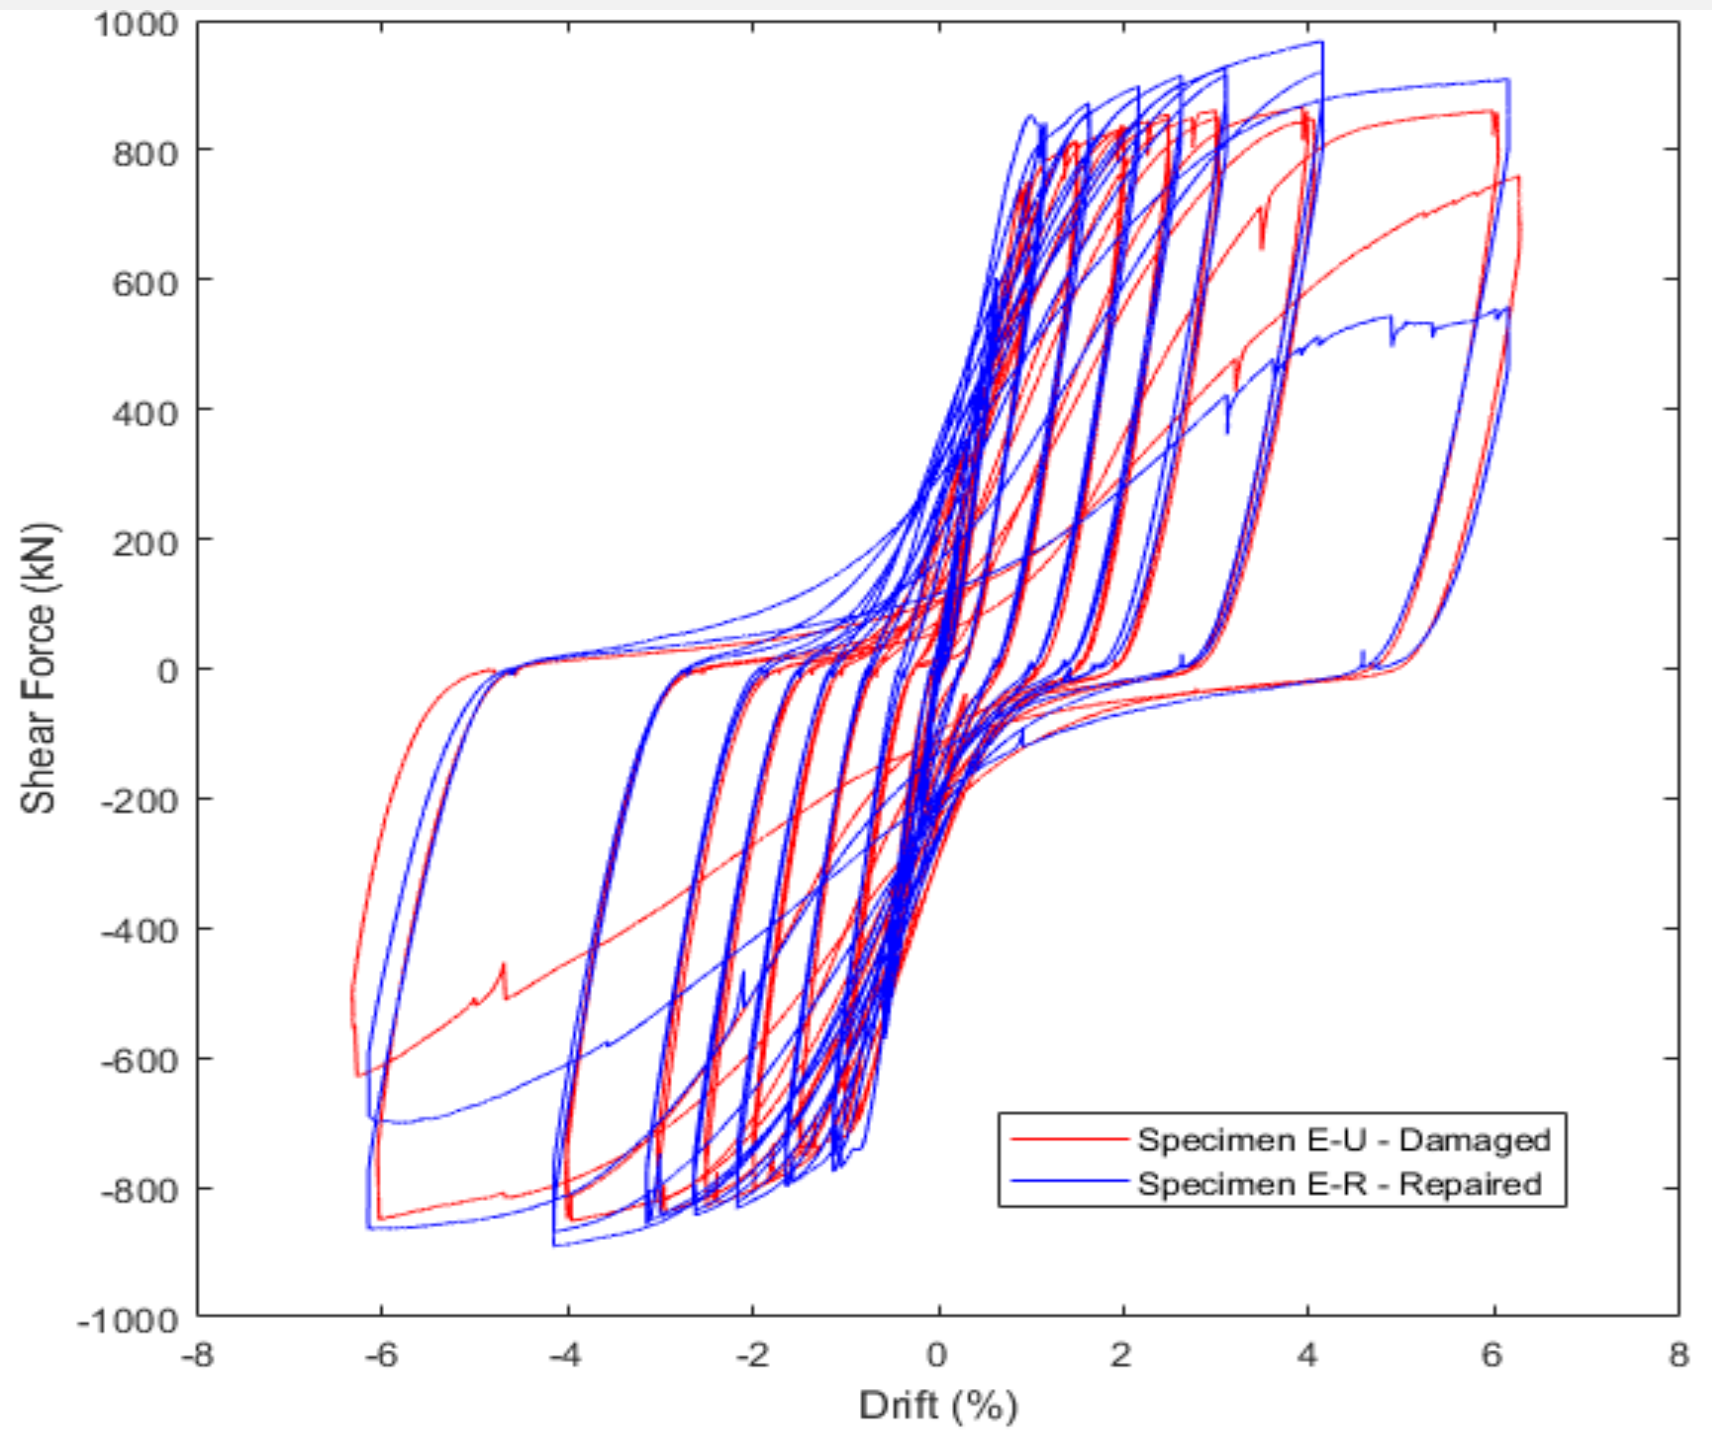
Figure 2: Hysteresis Plots for Specimen E-U (Red) and E-R (Blue).

- Specimens saw significant spalling at 4% drift with signs of core crushing. Following cycles to 6% drift buckling of longitudinal reinforcement was also evident. All specimens saw a 20% drop in strength on the second cycle to -6% drift coinciding with the unhooking of the stirrups. No bar fracture was observed (See Figure 2 for comparison of hysteresis for specimen E-U and E-R).

- The repaired specimen E-R had a 26% increase in secant stiffness to yield compared to its unrepaired counterpart, E-U.
- The repaired specimen had a yield strength ~10% higher than the unrepaired specimens and ~25% higher than the predicted overstrength, likely as a result of the strain aging phenomenon of the Grade 300E reinforcement.
